Solutions Flash

Economic and Effective Hardfacing Strategy for
Ground Engaging Tools (GETs) and Cutting Edge Shrouds

SF-0027.2 – August 2022

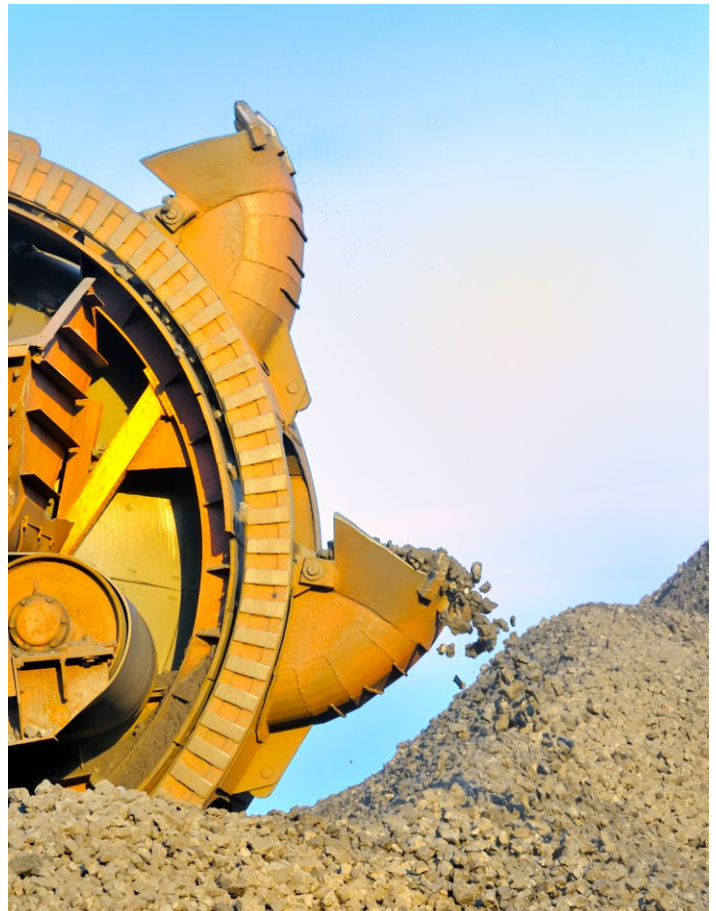
Figure 1. GETs come in many sizes and shapes, such as the bucket wheel excavator shown here. They can also encounter many different types of operating environments. The best hardfacing strategies will take these factors into account.

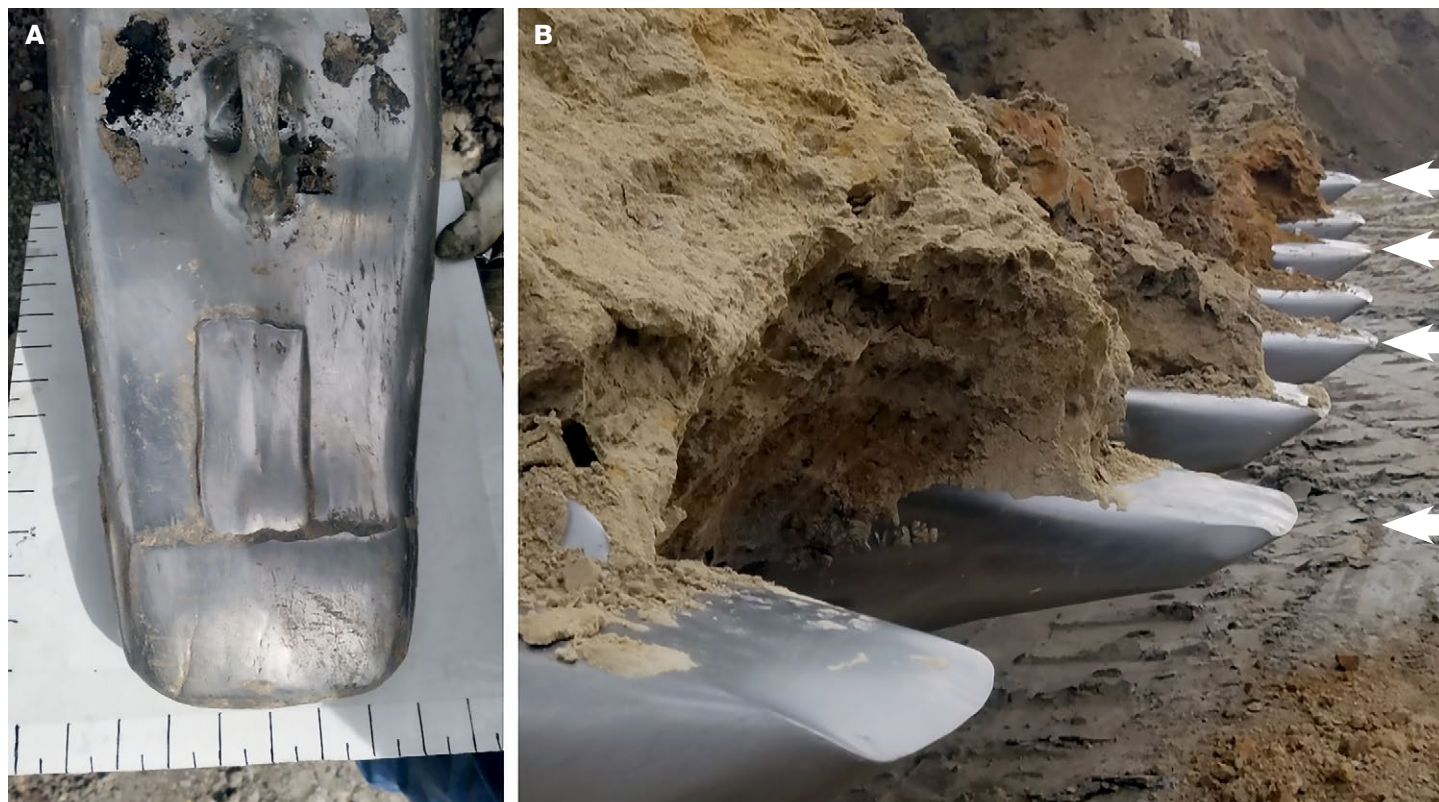
This trial was deemed a success, as the hardfaced teeth lasted 1.5- to 2-times longer than the teeth without hardfacing, and remained roughly 40 mm (1.6 in) longer than

adjacent teeth without hardfacing (Figure 8B). The 2-times increase in GET lifetime through utilization of hardfacing with aligns with several other trials where Metco 8247 was used as the hardfacing material.

Figure 8. Trials using Metco 8247, a non-cracking hardfacing, GETs in service. **A:** Close-up of hardfaced GET. **B:** Comparison of hardfaced and unhardfaced GETs. White arrows highlight the hardfaced GETs. Notice that the hardfaced GETs are longer and less worn, attesting to the abrasion resistance of Metco 8247.

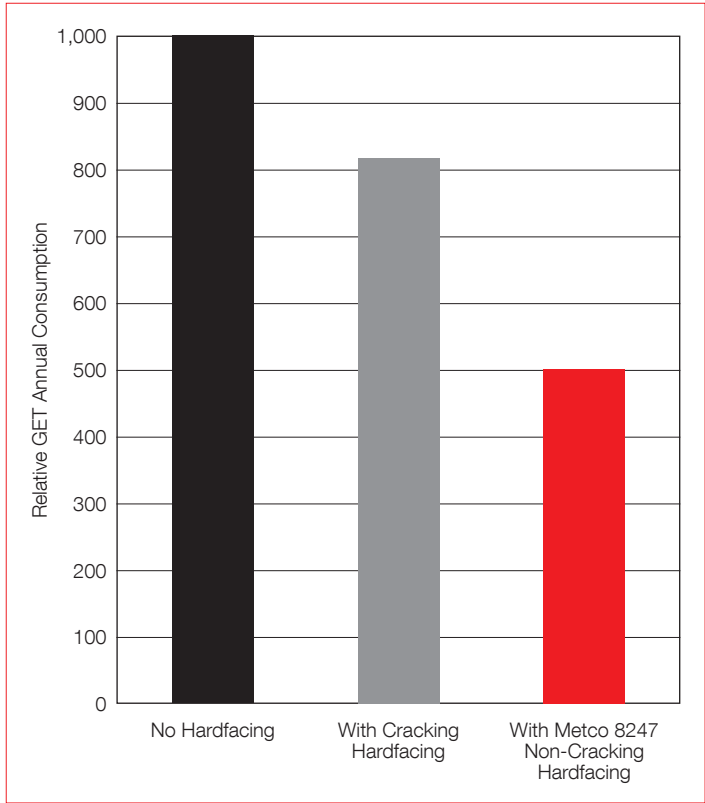
The economic comparisons of using unhardfaced GETS versus GETs hardfaced with a cracking deposit versus GETs hardfaced with a non-cracking deposit are summarized in Figure 9. This clearly shows the economic benefits of using a non-cracking hardface material such as Metco 8247.

Figure 9. Relative, normalized comparison of annual GET consumption considering various forms of hardfacing. Without hardfacing, GETs will wear as a result of abrasion and crack as a result of impact. With a traditional hardfacing, the abrasion issue may be mitigated, but a crack in the hardface as a result of impact will propagate into the GET causing failure, which can actually crack at a higher rate than unhardfaced GETs. Using Metco 8247, both abrasion and impact are mitigated, and the hardfacing does not crack, leading to the highest-performing and most cost-effective hardfacing strategy available on the market today.
